MONTECITO RANCH

APPENDIX N

**LIMITED PHASE I AND II
ENVIRONMENTAL ASSESSMENTS**

**SUMMARY OF LIMITED PHASE I
ENVIRONMENTAL SITE ASSESSMENT
935-ACRE MONTECITO RANCH, RAMONA
SAN DIEGO COUNTY, CALIFORNIA 92065**

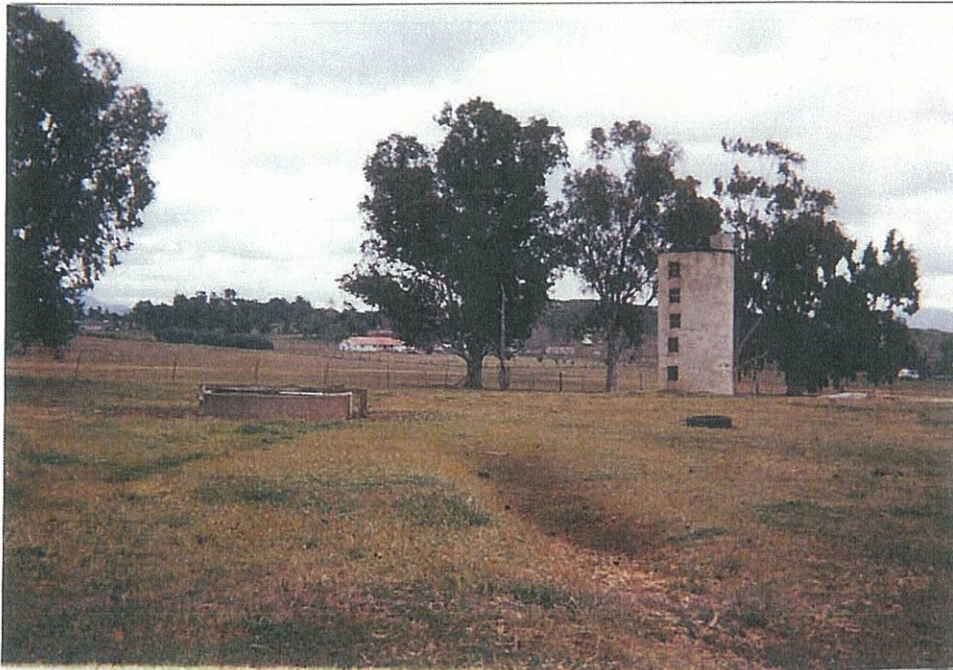
2. Grain silo and watering hole across driveway from main residence. View to the east, includes pasture land along the southern property boundary.

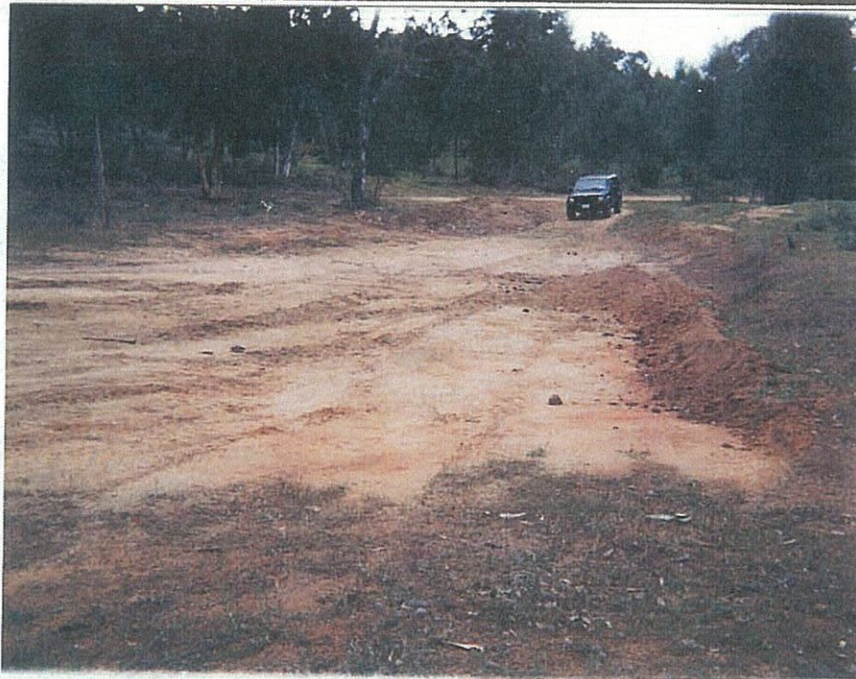
3. Excavation area in south central portion of ranch property. Area, located within rectangular tree cluster, was the previous location of the ranch dump. View is to southeast.

- All pertinent reports of the removal of the stockpiled trash should be provided to this office for review. Dependant upon the information provided, verification sampling may be considered to evaluate the existence of detectable chemical residues (if any).
- Considering that the majority of groundwater wells were abandoned by the previous owner at least 10 years ago, GSI recommends that all abandonment records/files be provided to verify that proper State of California abandonment procedures were followed (California Well Standards Bulletin 74-90). If proper records are not available, consideration may be given to contacting the California Department of Water Resources for their files. Although unlikely, wells onsite without proper abandonment records may need additional evaluation and possibility re-abandonment.

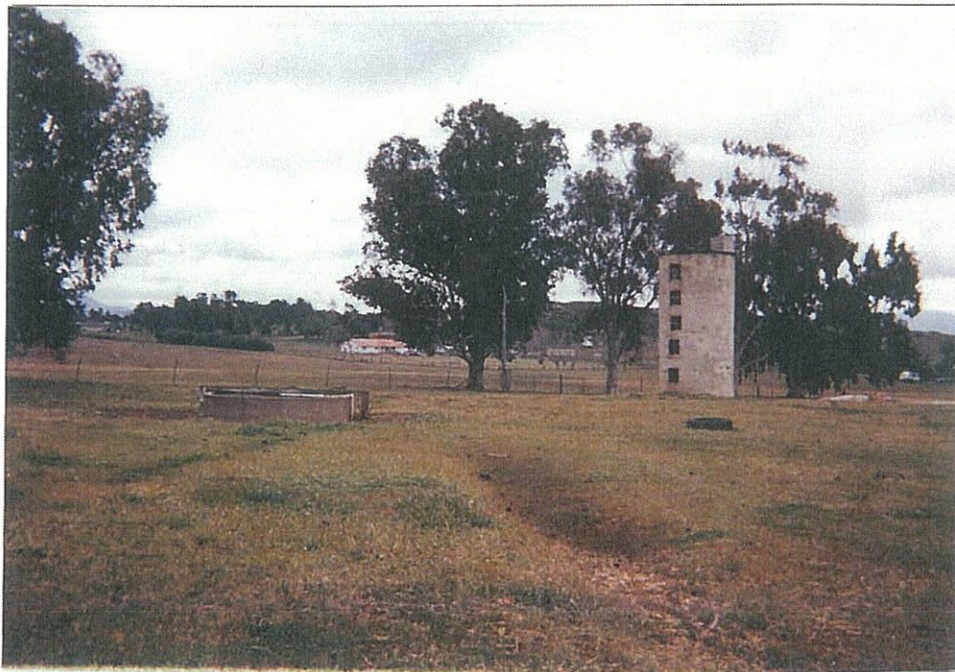
2. Grain silo and watering hole across driveway from main residence. View to the east, includes pasture land along the southern property boundary.

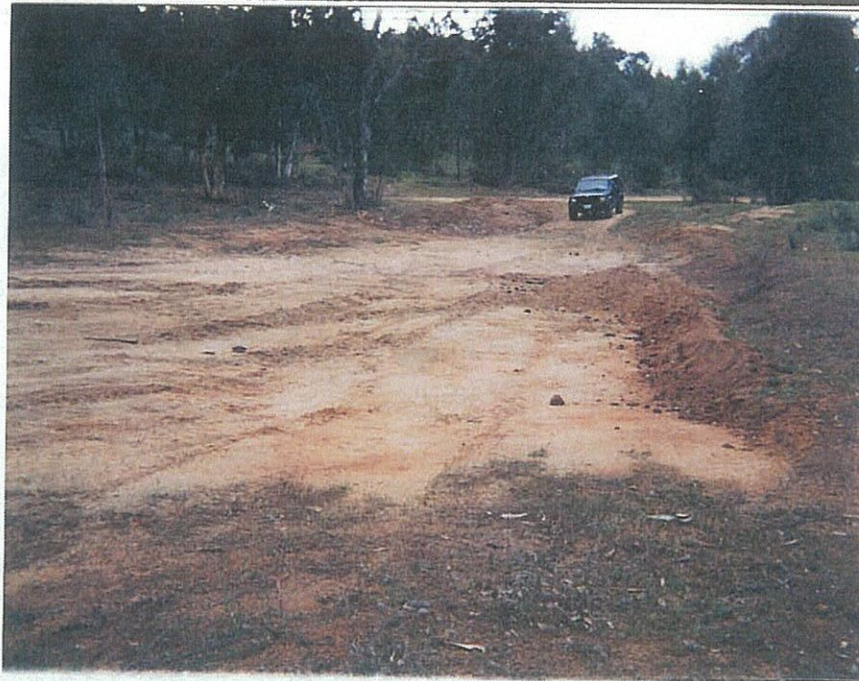
3. Excavation area in south central portion of ranch property. Area, located within rectangular tree cluster, was the previous location of the ranch dump. View is to southeast.
